An experimental fatigue study under condition where cyclic corrosion-fatigue interaction occurs

Firas Ali Jasim Al-Mahaweli¹, Saad A. Khuder Alsaraf², Hussain Jasim Mohammed Al-Alkawi³

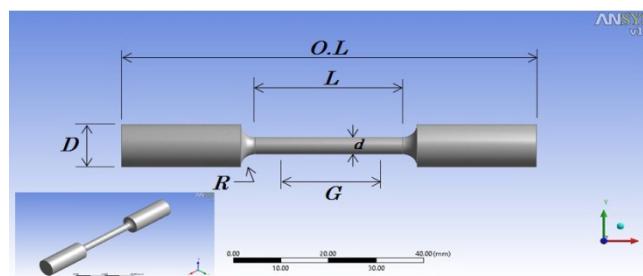
Figure 1. Tensile test specimen (all dimensions in mm) accorded to ASTM (E8/E8M-09) specification [9].

The mechanical properties of (7075-T6) aluminium alloy were obtained according to ASTM B-211 specification. The tensile specimen can be shown in Figure 1 and Table 2 respectively, while the mechanical properties are listed in Table 3.

Table 2. Standard shape distance according to ASTM (E8/E8M-09) specification [9].

Symbol	Descriptions	Dimensions in (mm)
D	Diameter of Grip	16
d	Diameter of Gage Length	9
G	Length of Gage	36
L	Length of Reduced Section	45
O.L.	Overall Length	87
R	Fillet Radius	8

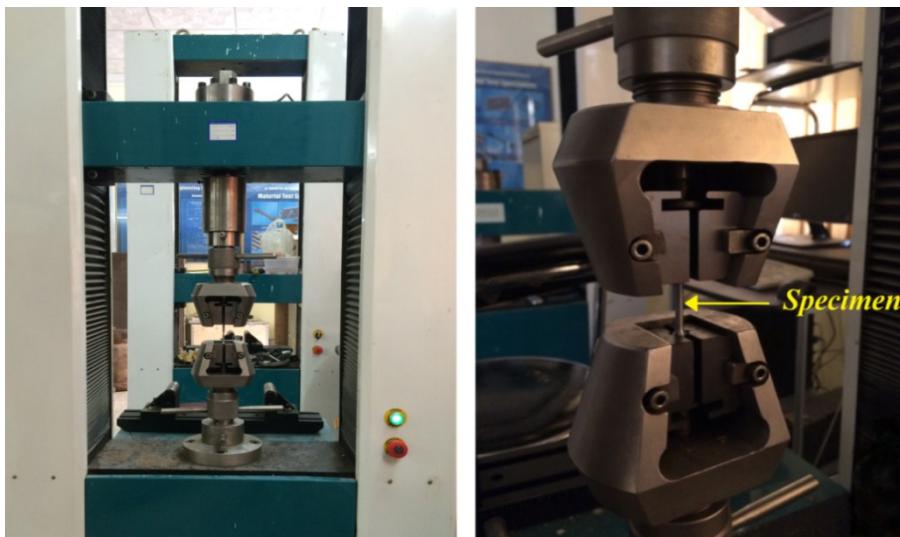
Figure 2. Tensile test machine (Tinius Olsen).

The tensile test was conducted using the test machine (Tinius Olsen) with a capacity of 100KN shown in Figure 2 in University of Al-Mustansiriya, Material Engineering Department.

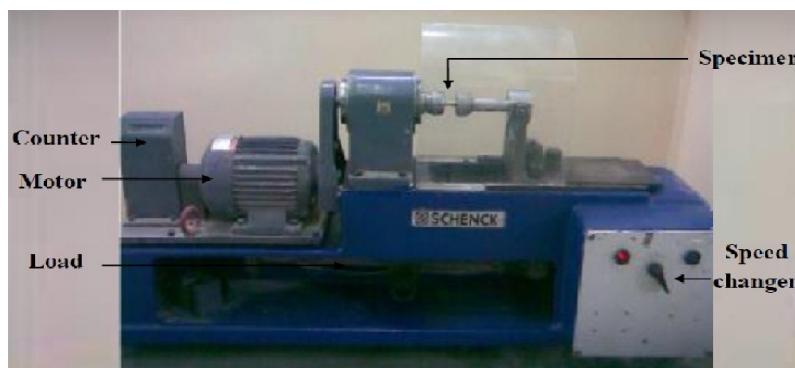
Figure 3. PUNN rotating bending testing machine [10].

A fatigue-testing machine Schenck product of type PUNN rotating bending was used to execute all fatigue tests, with variable and constant amplitude loading as illustrated in Figure 3 [9].

The specimens of the fatigue test which is illustrated in Figure 4, has a circle section and is subjected to vertical load, which created a constant bending moment. The load unit is (N) which can be used to determine the applied stress to (σ) in (MPa) using simple bending theory $\sigma=MY/I$, and after substituting the constant values the above equation can be taken the form,

$$\sigma = \frac{1280.369 * P}{d^3} \quad (1)$$

where the value 125.7mm represents the arm of force (P) and d is the minimum diameter of the specimen in millimetre [10].

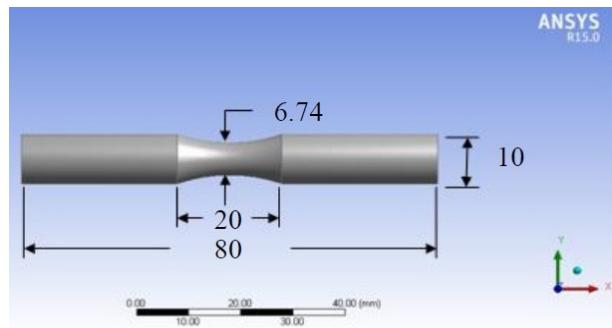
Figure 4. Dimensions of fatigue specimen in millimetre [12].

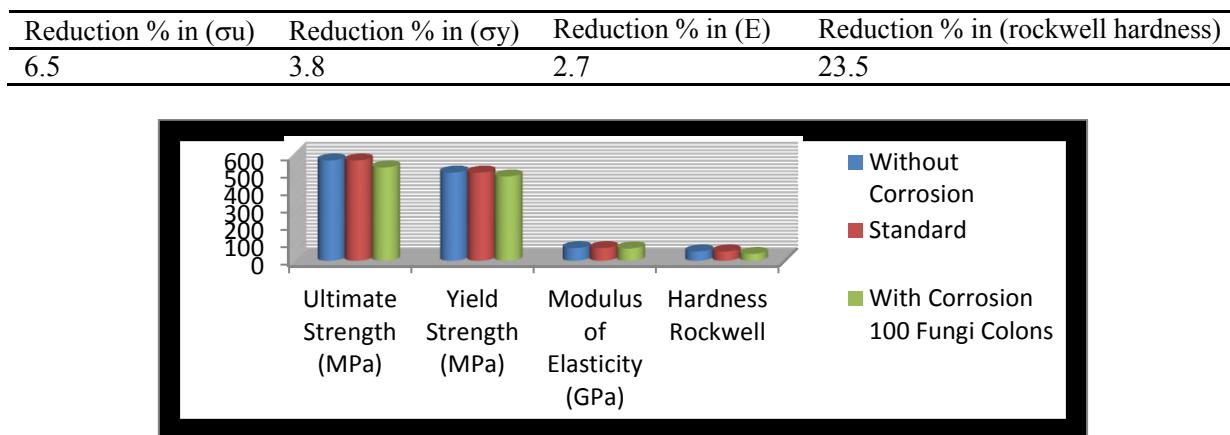
Figure 5. Effect of corrosion on mechanical properties.

The effect of 100 fungi colonies corrosion on the mechanical properties can be shown in Table 6 and Figure 5. It is clear that the tensile strength reduced by 6.5% compared to the experimental while the yield strength reduced from 500 MPa to 481 MPa by 3.8% reduction compared to the measured value. The significant reduction is happen in Rockwell hardness. The surface hardness reduced by 12 i-e 23.5% reduction compared to the actual value. The modulus of elasticity was slightly reduced.

The corrosive media creates pits at the surface these pits work as a stress raiser in which reduce the mechanical properties and resulting to weak resistance against failure. The above findings agreed well with that concluded by Dong et al [11].

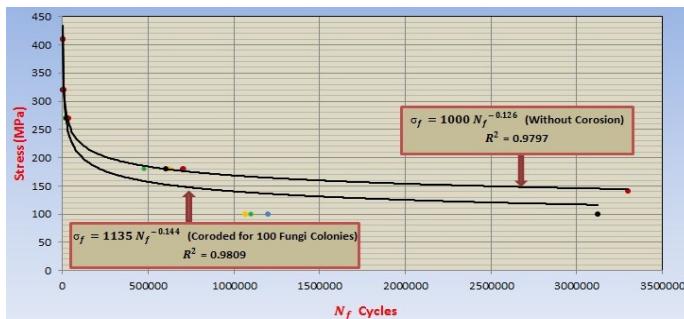
Figure 6. Traditional constant stress amplitude S-N curves for two fatigue conditions.

Figure 6 shows the variation of corrosion between dry and pre-corroded fatigue specimens. The behaviour of the S-N curve indicates that the fatigue life of pre corroded specimens decreased compared with that of as received specimens. And the fatigue strength is reduced by 15% compared with dry fatigue strength, as given in the Table 8.

Fatigue crack initiation sites are associated with surface defects like pits or other discontinuities. These pits work to reduce the mechanical and fatigue properties of the metal [12]. The fatigue strength of corroded metal always less than the as-received as given in Table 8.
